THE ONTARIO POWER COMPANY OF NIAGARA FALLS

REPORT

ACCIDENT ON APRIL 20th, 1922

WALTER J. FRANCIS, C. E.

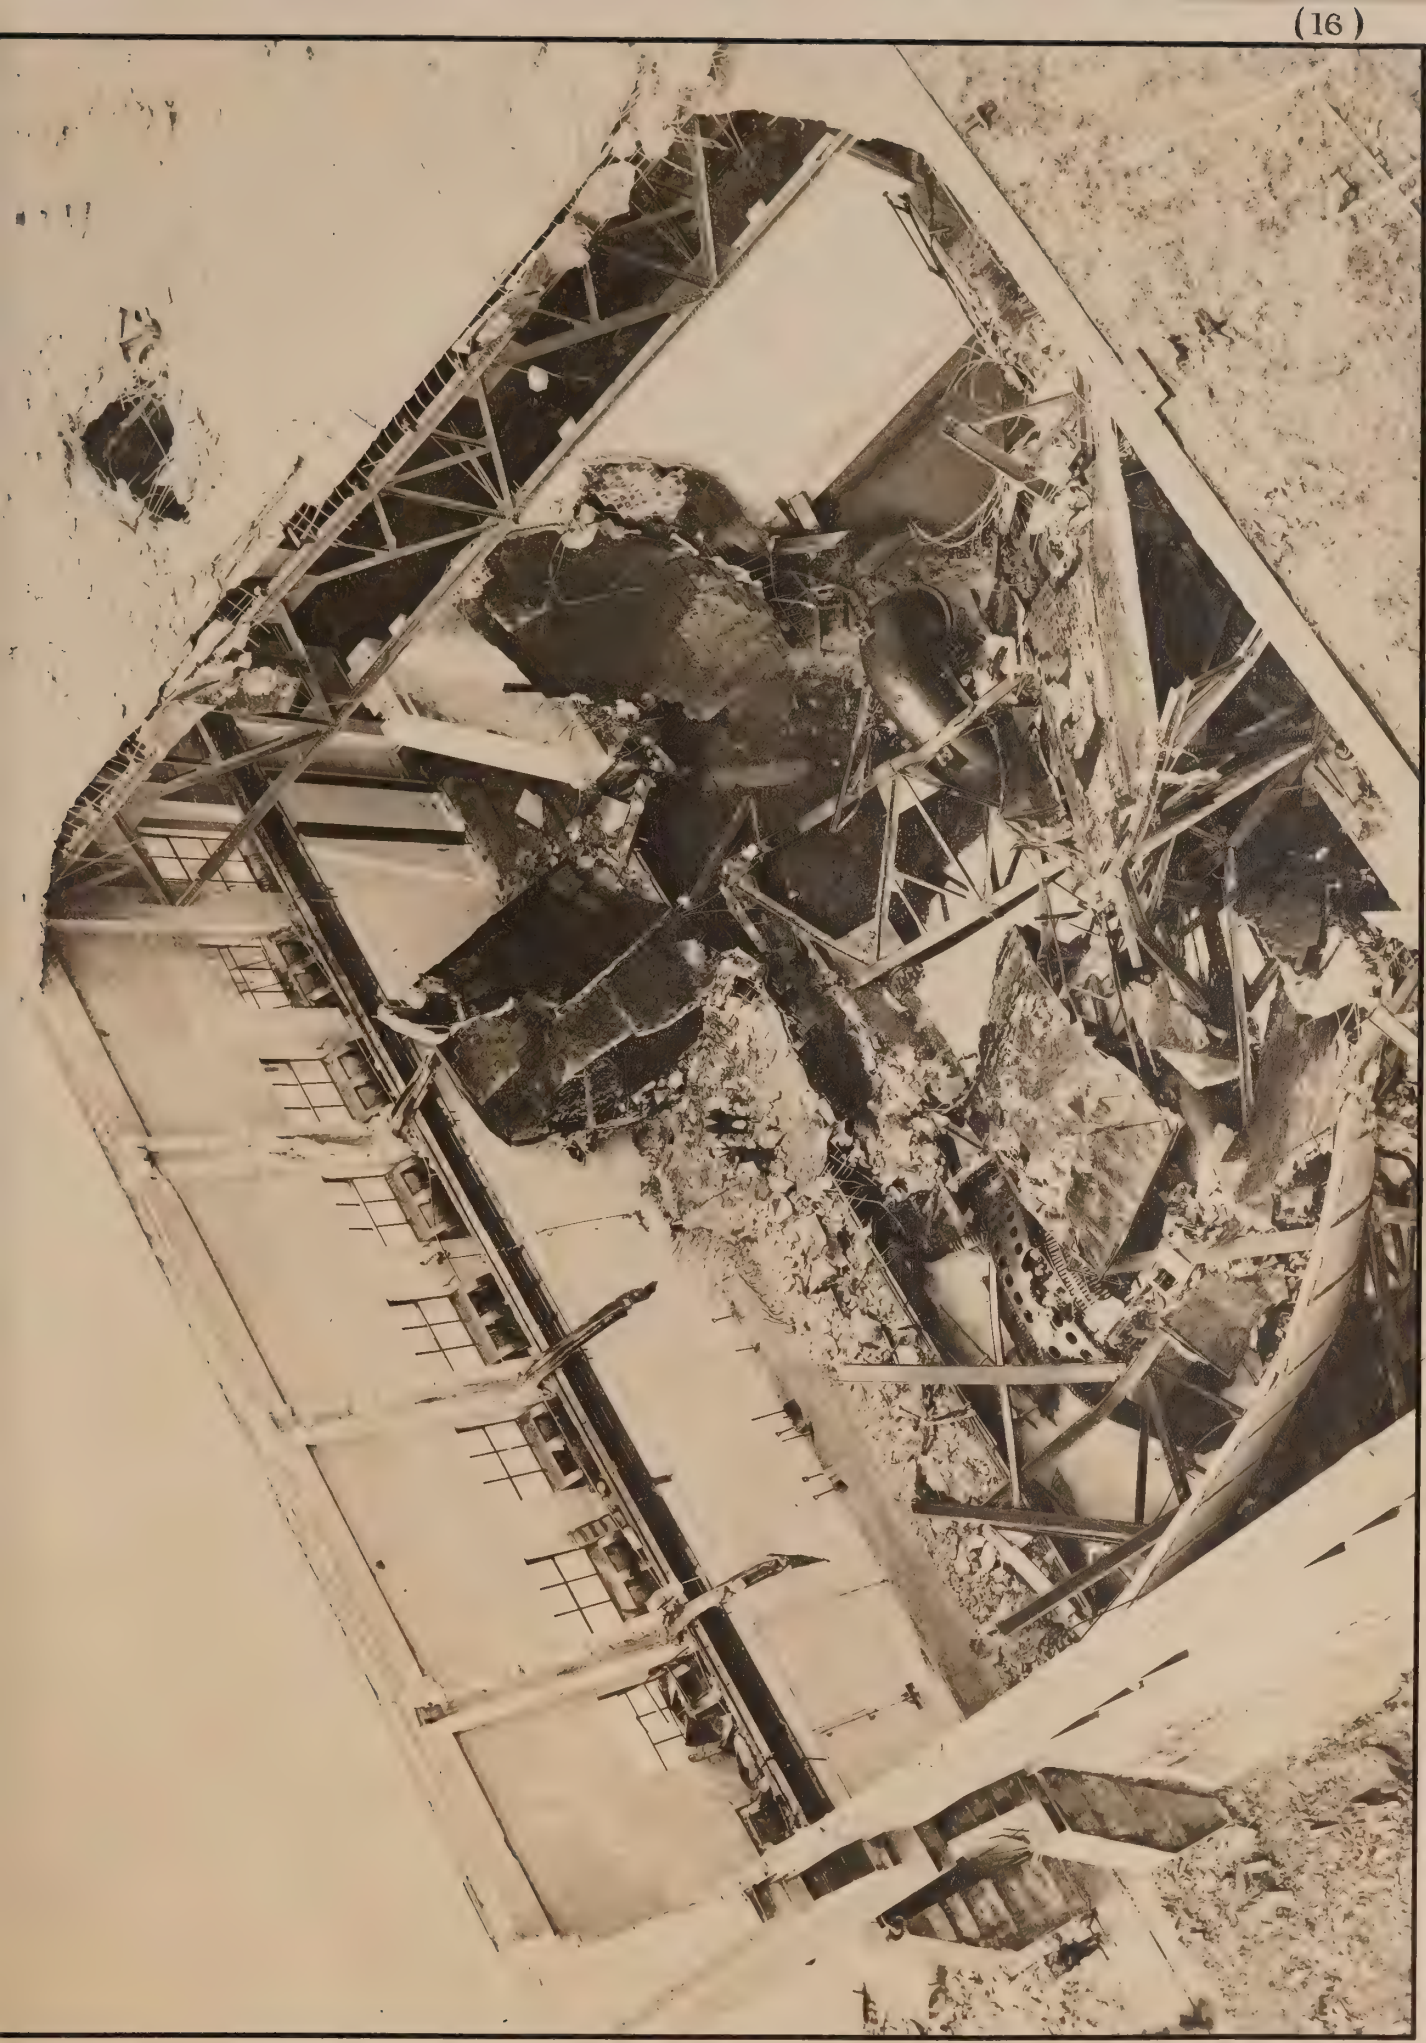
Taken April 20th, 1922.

looking down on Power House from above.

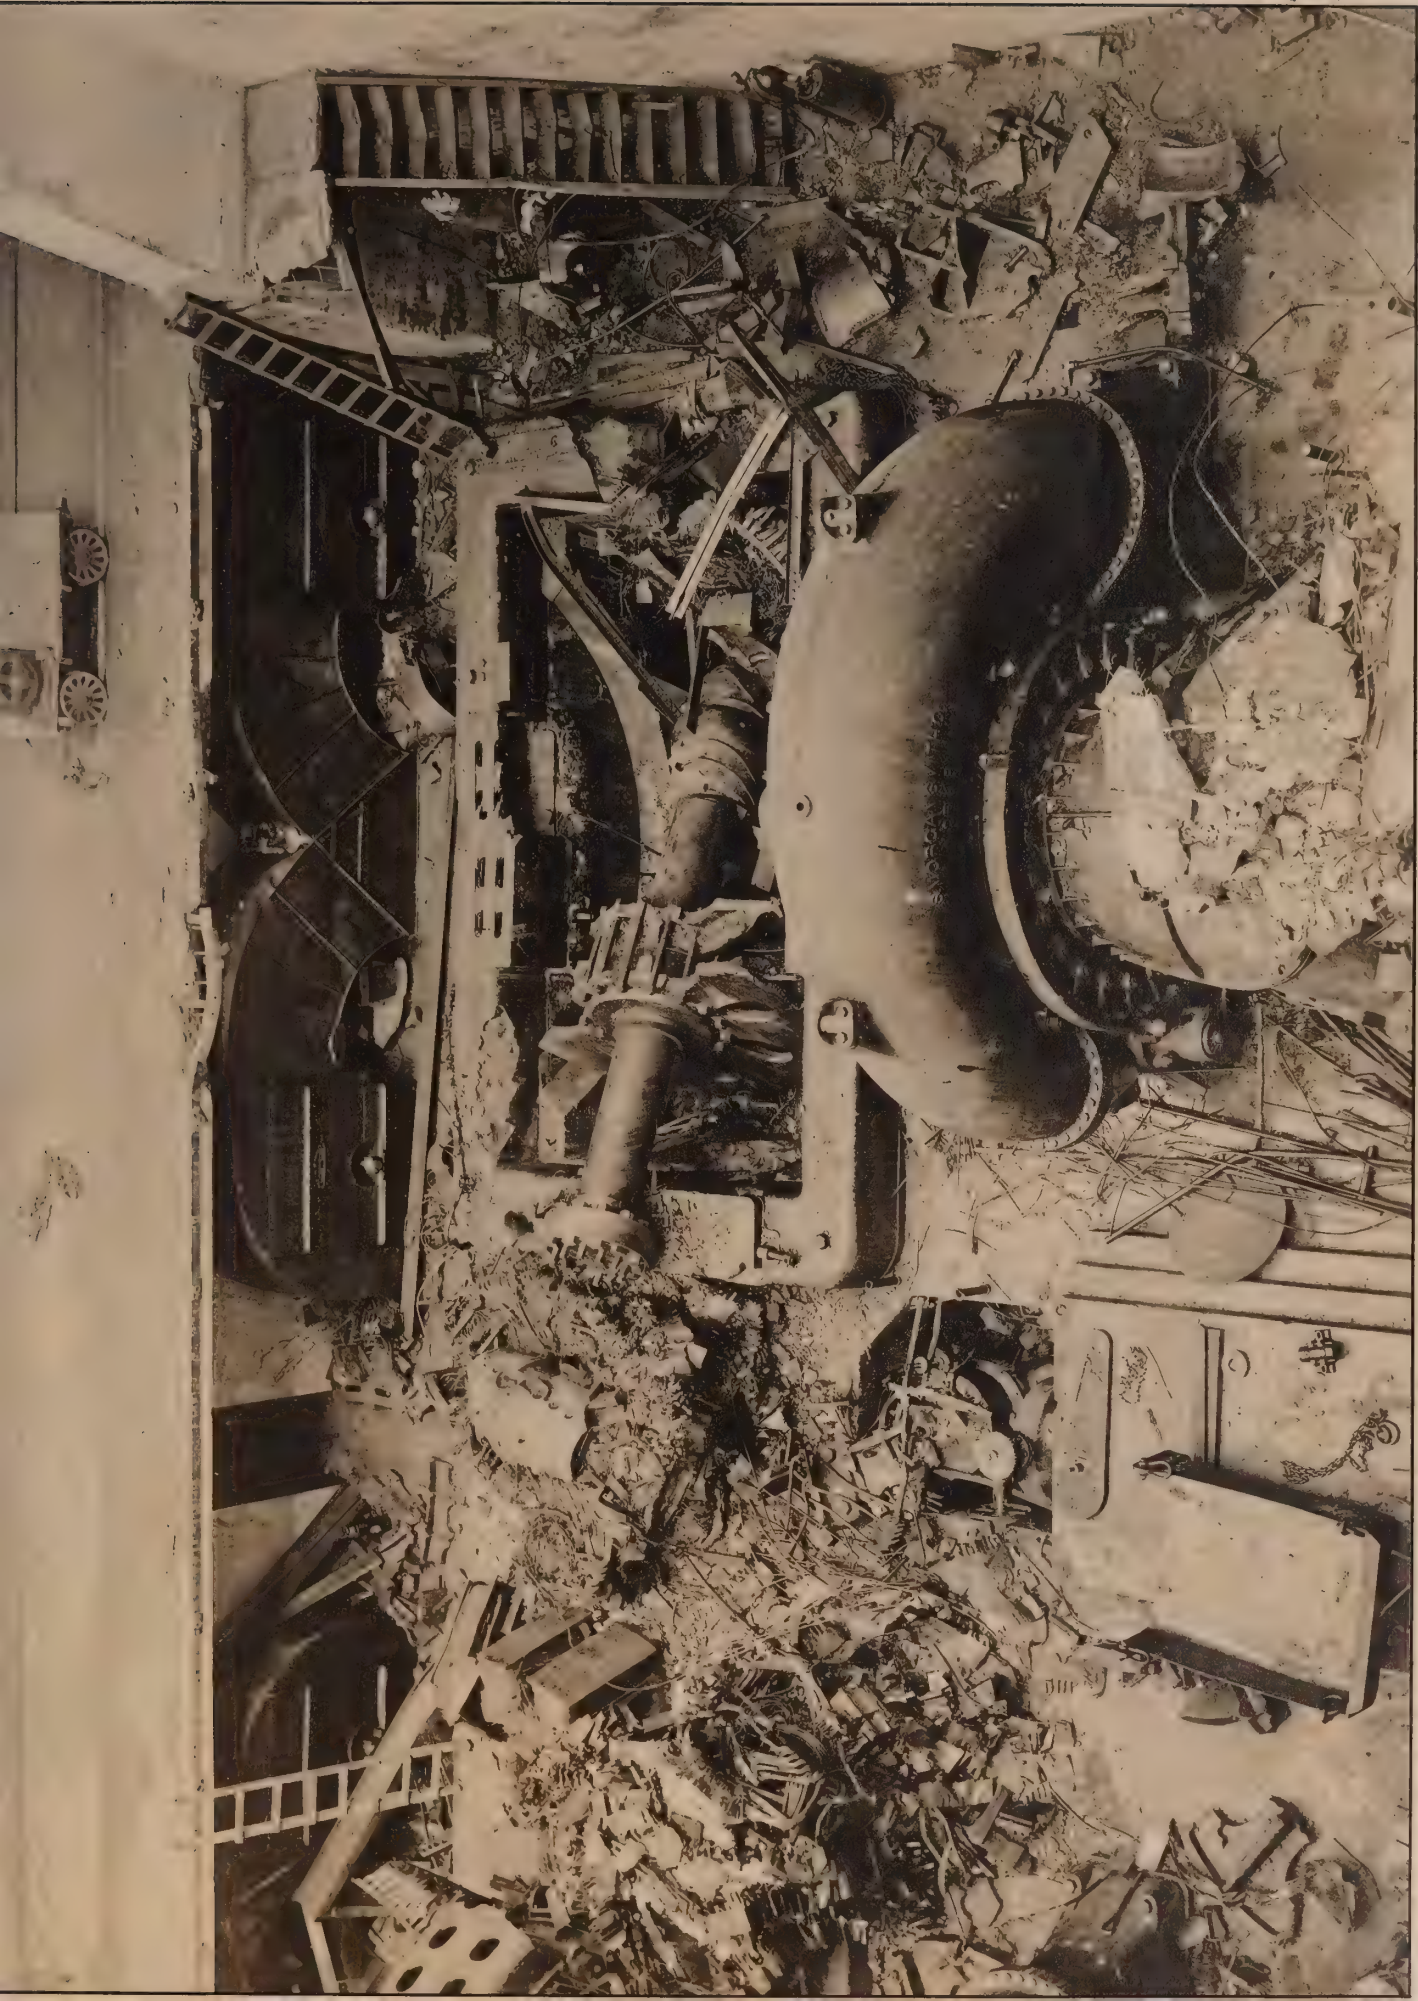
Taken May 15th, 1922.

looking from above.

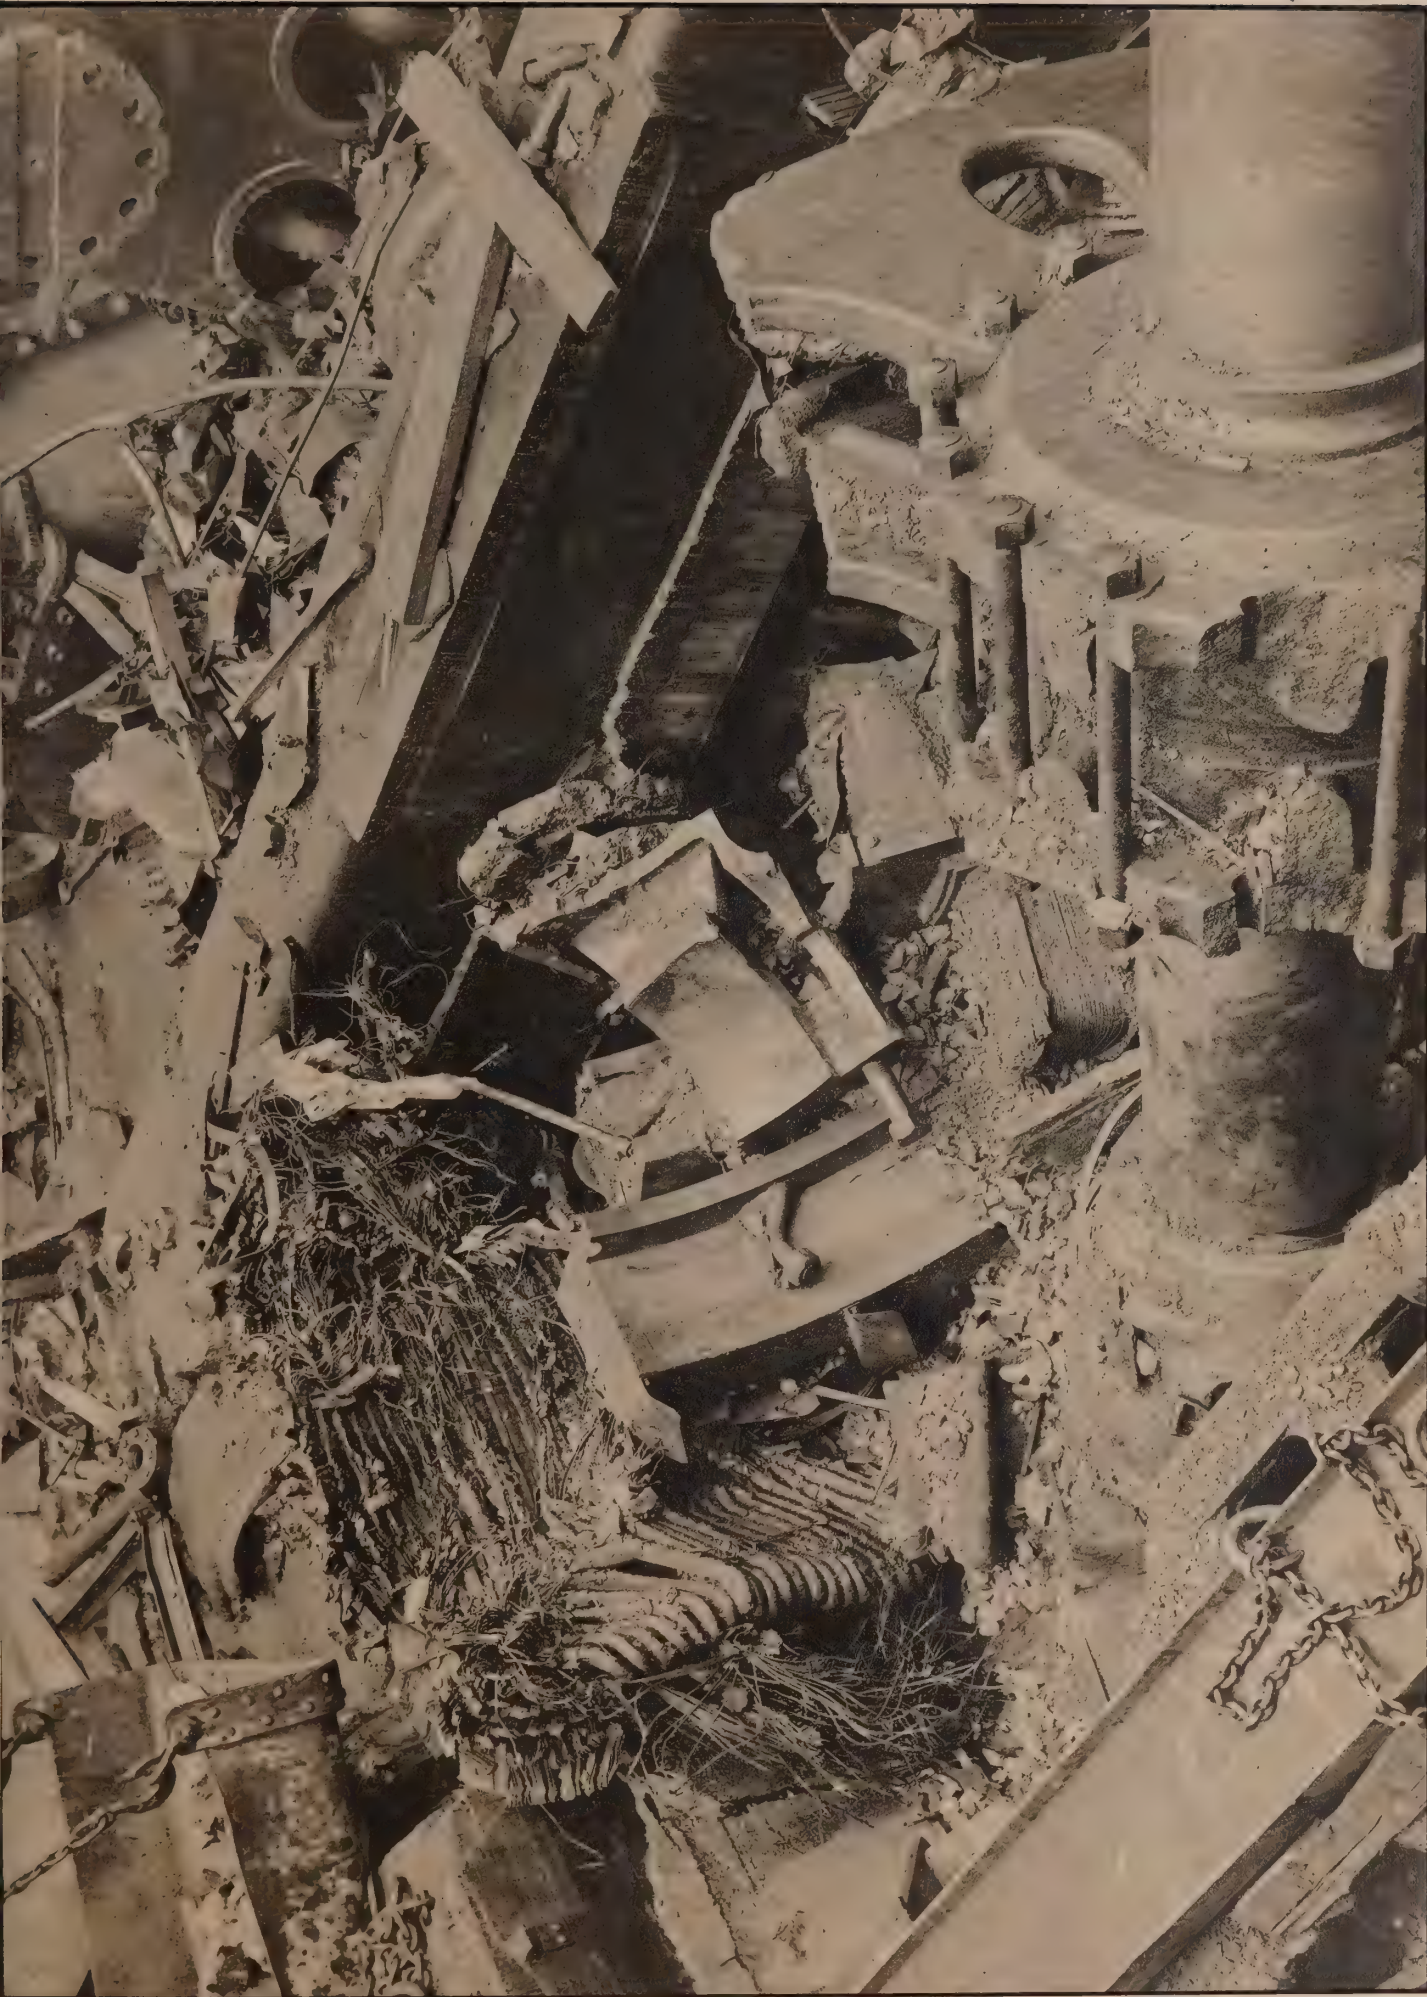
Taken May 21st, 1922.

Detail View of Wreckage of Generator No. 18.

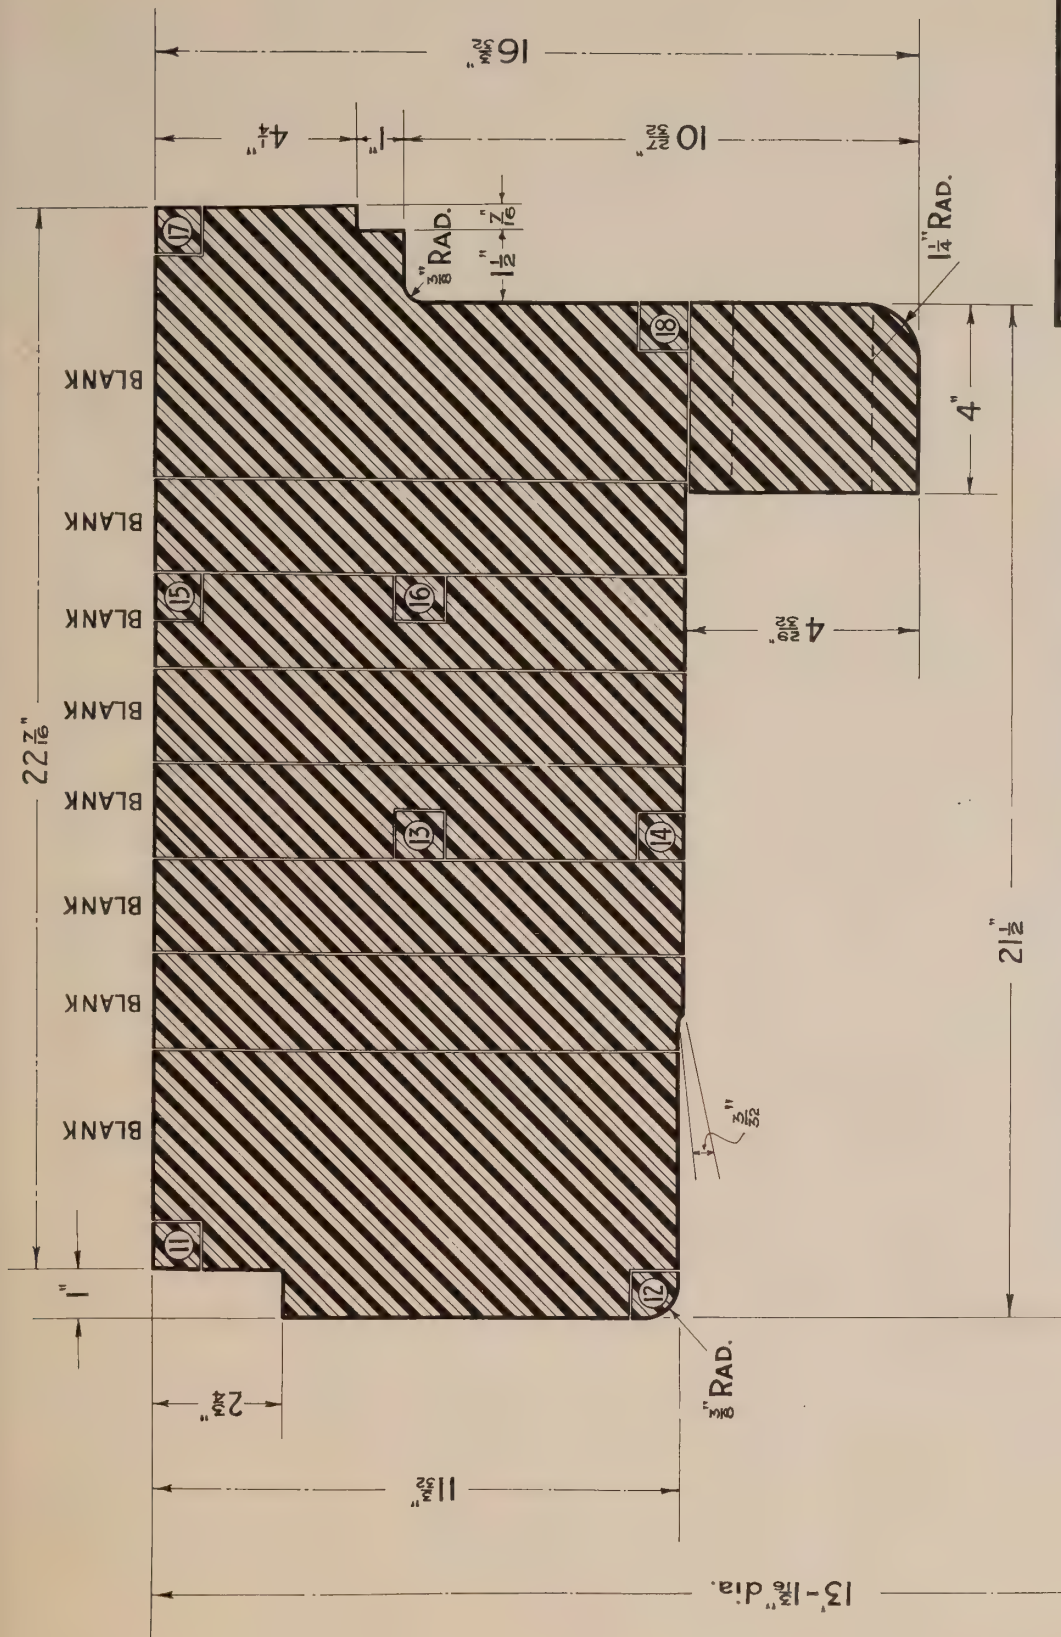
Sheet 4

CROSS SECTION OF STEEL CAST ROTOR RING

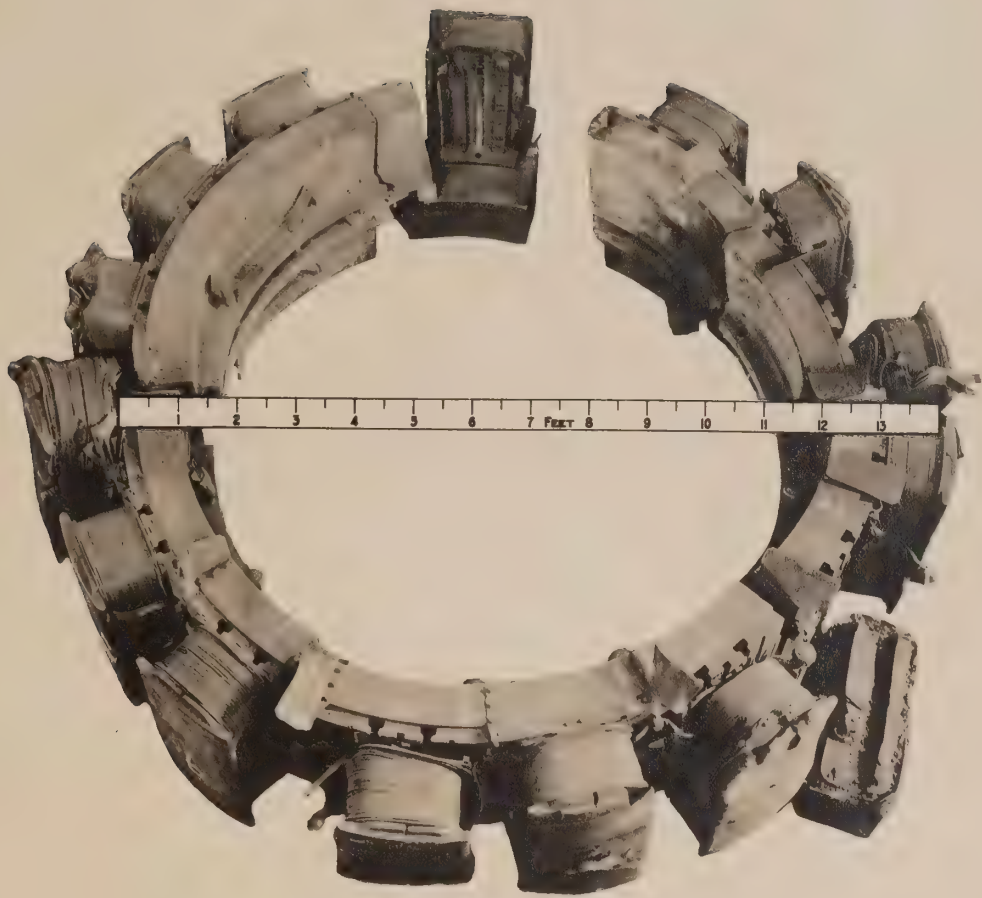
Taken November 15th, 1922.

After the building debris had been separated from the wreckage of the machinery, the fragments of the two steel cast rotor rings of generator No. 15 were assembled in order on the floor of the room, and finally checked over to confirm their positions. The drawing included herewith as page 26, entitled "Details of Rotor Rings of Generator No. 15 after the Accident", shows in elevation view the actual position of the fractures in both rings, while the photograph included herewith as page 27 shows the assembly of the fragments lying in a circle on the floor.

The fractures of the rings show a very considerable variation in the quality of the steel, evidenced to the practised eye by the crystalline structure which varies generally from a fine grain near the outer walls of the castings to an exceedingly coarse grain towards the heart of the castings. Moreover, the fractures vary among themselves, and altogether show an utter lack of homogeneity.

Assembly of Fragments of Motor Links on Power House Floor.

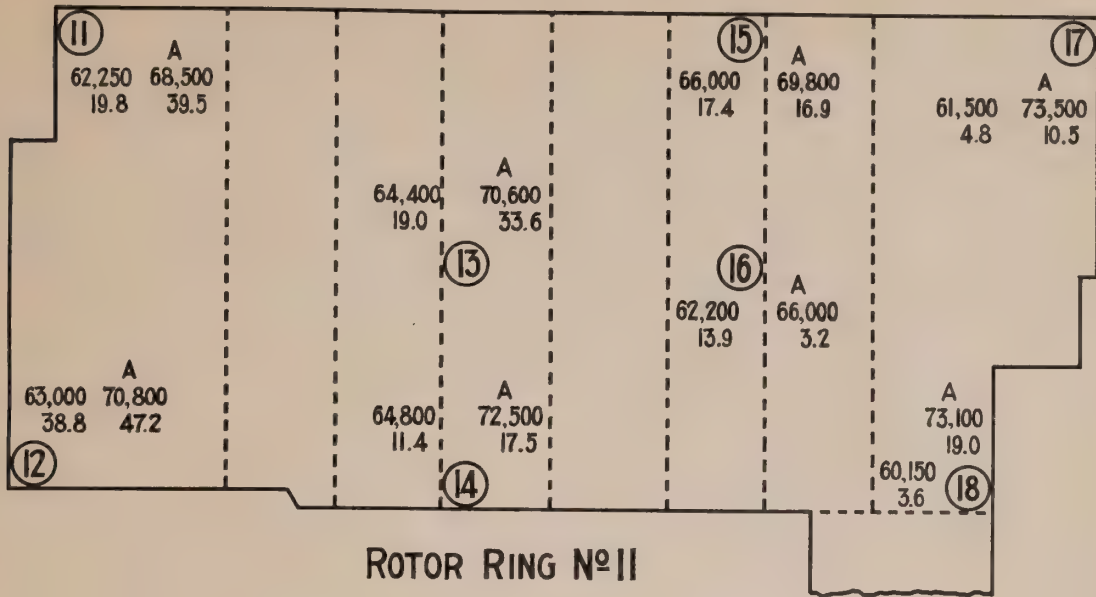
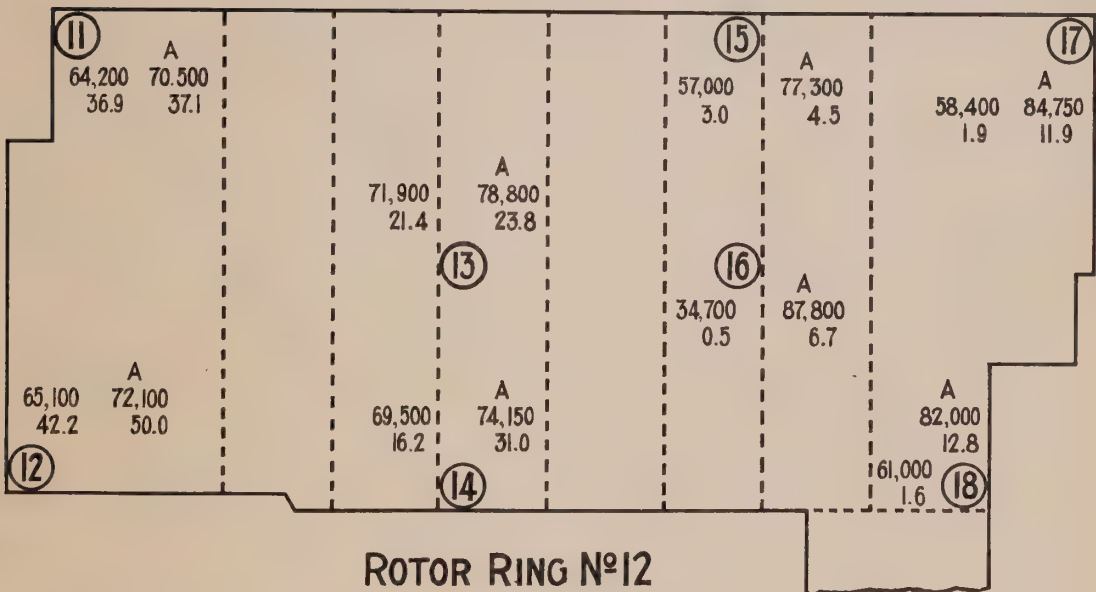
Sheet 6

The tests on the thirty-two specimens confirm the general finding in every instance, piece by piece and ring by ring, especially in regard to the percentage of elongation and the percentage of reduction in area, the two factors which indicate the ductility of the metal. It will be observed that even these factors vary between very wide limits, not only in the untreated specimens, but also in those cut from the annealed metal. It is doubtless beyond the scope of my instructions to do more than point out a very interesting divergence in the figures regarding reduction in area on the left hand side of the cross section of both of the rings as compared with the right hand on the drawing included herewith as page 41. In every case the ultimate strength and the elastic limit was materially improved by the heat treatment. This drawing is self explanatory, and would appear to indicate a result due to a definite foundry practice regarding the details of which I am unaware. As already stated, each of the rings in the rough weighed over twenty-two tons, and it will be seen that it was necessary to handle a very large amount of molten metal in making the castings.

NOTE - (16) denotes number and location of test specimens.
